[DRAFT] WCC Walk Notes – June 7, 2025 7:30a – 9:45a submitted by T. Failla, Conservation Planner., with assistance from M. Jung, WHS Senior intern Present: M. Francois (for all 3 properties); A. Squance (for first 2 properties); A. Cottone (for 3rd property; A. Squance recused). (*see attached document with photos*)

# 367-369 G-Town Storm-Damaged In-Stream Culvert Repair/Replacement – Grodman/Kusek

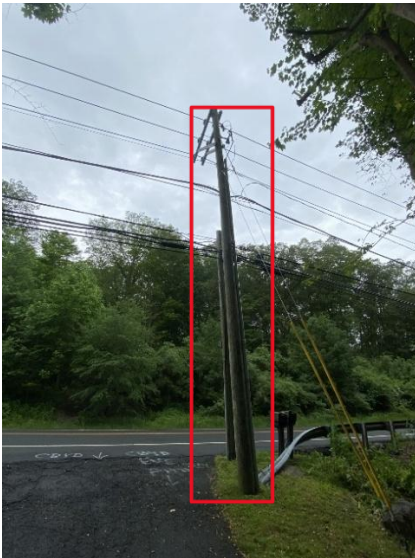
View east to Rt 57 U/G utilities.

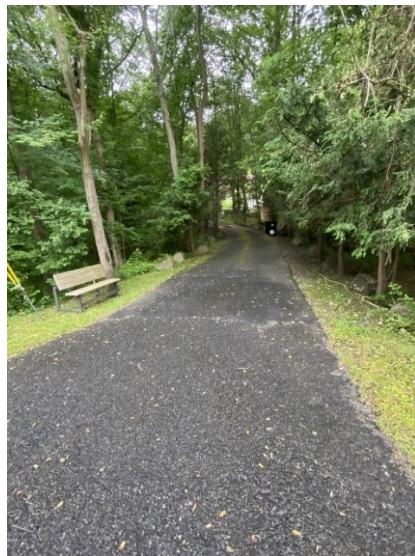
View west down d/w to 2 homes.

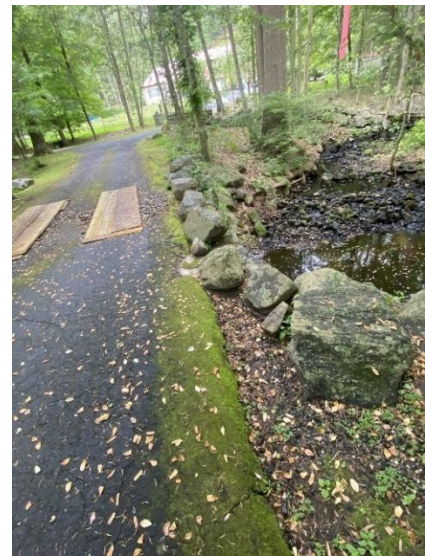
Temp wooden planks + stone.

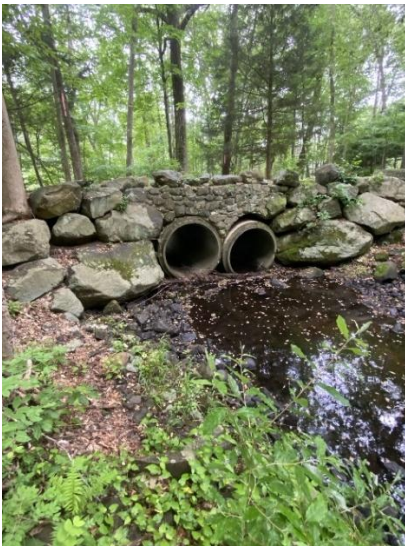
367-369 Georgetown – Storm-damaged, in-stream culvert and bridge repair/replacement. Property owners, Messrs. Grodman and Kusek, were present. Two 60-in culverts were undermined and separated from stone and earth bridge and wing walls first noticed after a storm in mid-March by the property owners. Grumman Engineering (Dean Martin) was engaged to prepare a plan for repair/replacement and assist with an application for a wetlands permit. The crossing is about 10x15 ft, work in stream about 10x35 ft., project area about 60x100 ft. Questions follow:

View S. downstream wingwalls & culverts undermined & separated from stone bridge.

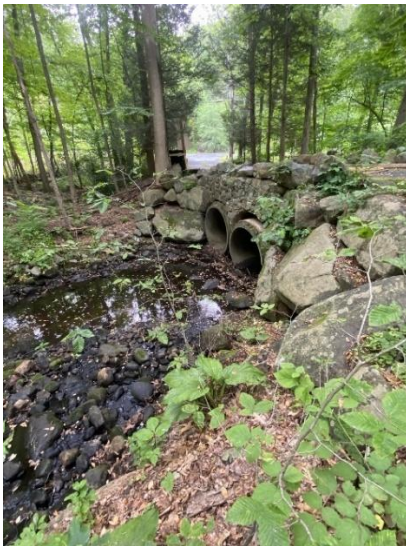
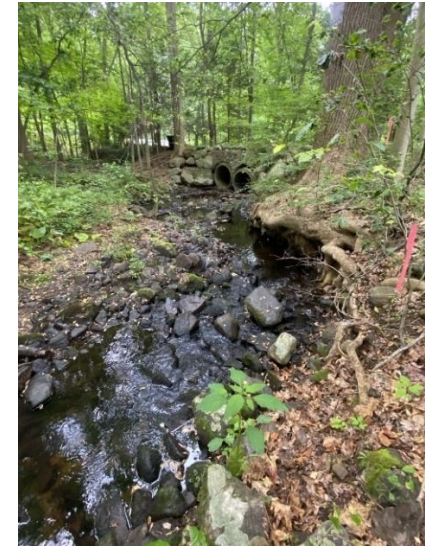
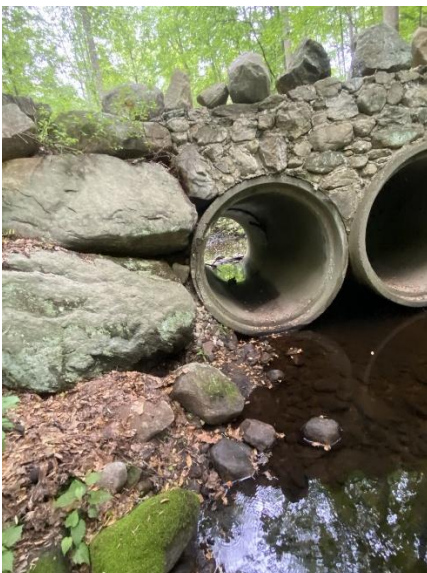
View N. Upstream two 60 in culverts upended w/o water flow.

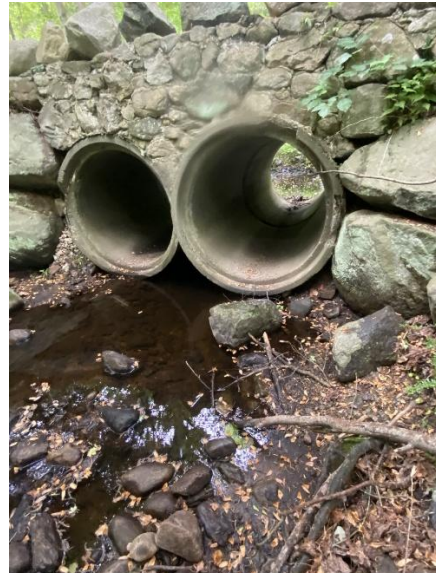
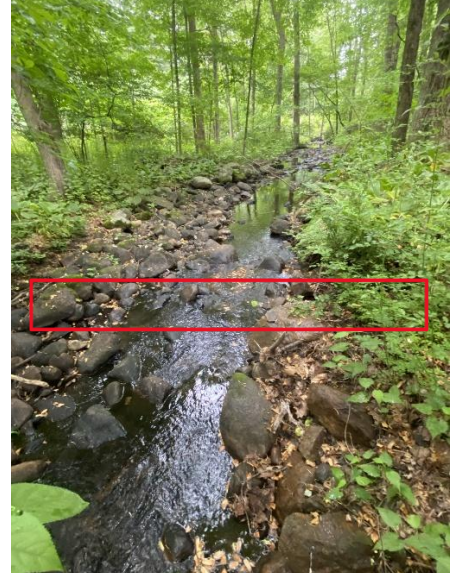
View S. downstream; haybale filters.

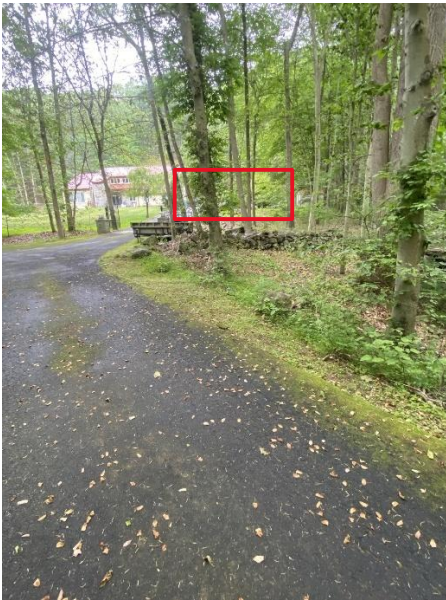
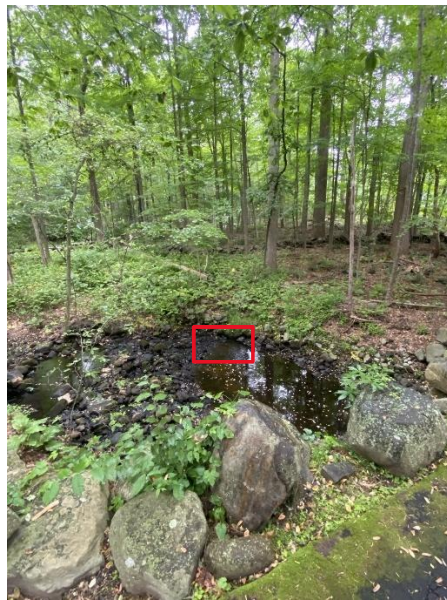
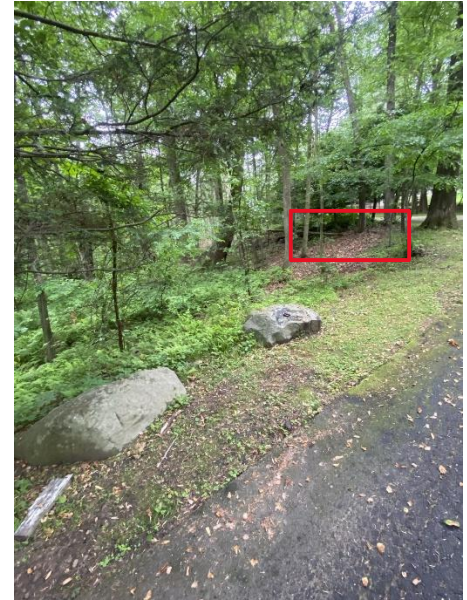
W.materials/equipment staging. N. upstream pump location S. dewatering area downstream

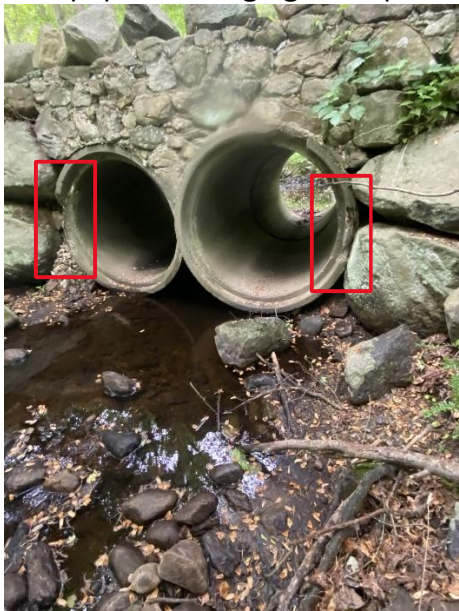
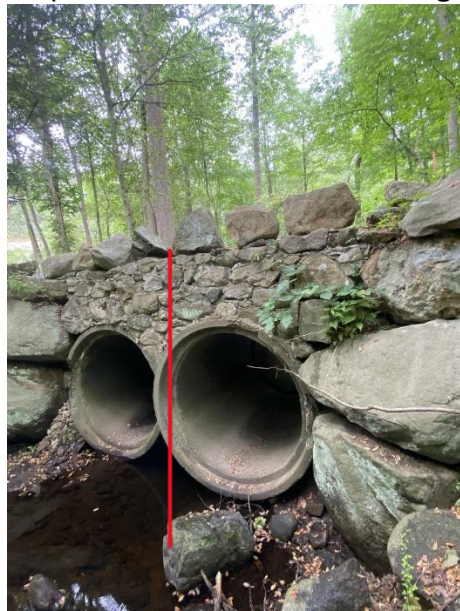
Culvert downstream edge damage. Ornamental boulders. No anchored rail. 7-8ft drop  
**90 Old Farm Site Development - Saini**

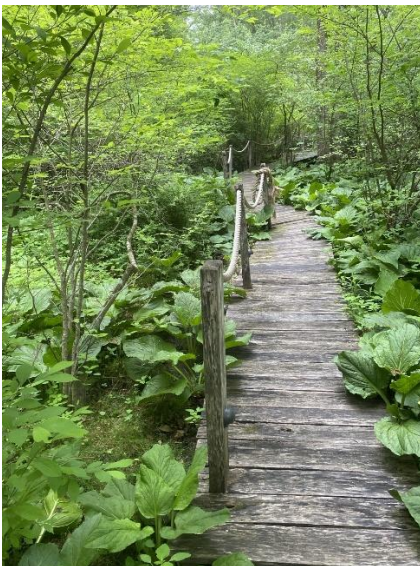
23-25 Walden Woods – Abigail Squance for Devore guided the group. About 75 ft boardwalk posts and some decking need repair in swamp (about 34% of the 220 ft BW in swamp; BW and path are about 270 ft). The original BW was permitted for passive recreation by the Commission about 18 years ago. Questions follow:

Failing boardwalk support.

1. How will work access and equipment/materials staging be protected during project and stabilized afterward?
2. Please provide written description of work sequence, methods and debris protection in swamp.
3. A single silt fence needs to be erected by hand immediately along the length of unpermitted excavation work within the regulated area along a stone wall at the edge of the wetland and debris removed by hand from the wetland side of the stone wall.

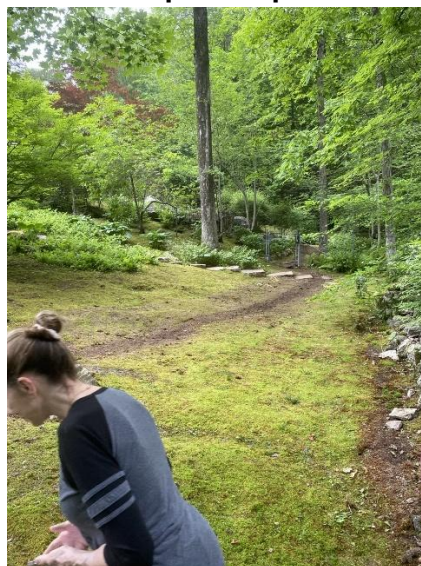
Materials/Equipment staging
