Field Investigation: Erosion and Sedimentation Controls

Date:	October 3, 2025	CC:	
Investigator:	Aleksandra Moch	Address:	45 Cedar Hills
Project Activities	Fill removal and wetland buffer restoration	Owner: Contact info:	Jonathon and Diane Gelbwaks

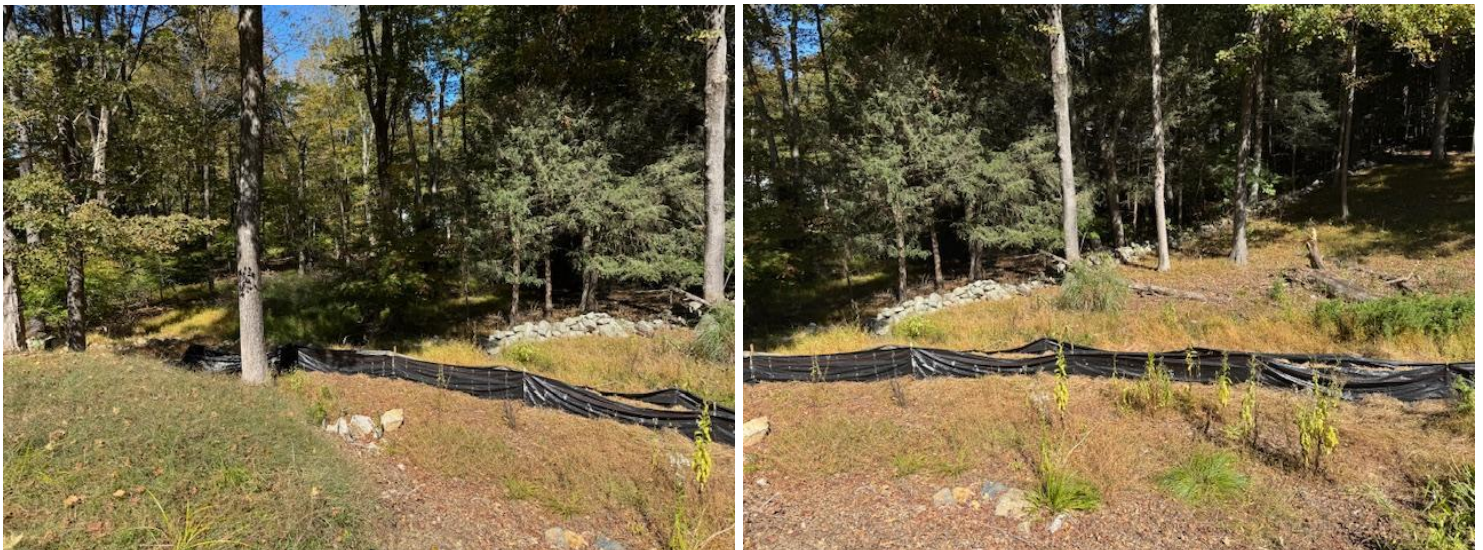
Control Measure	Inspection Notes
Silt Fence:	Two rows of silt fence with a line of hay bales in between were installed along the toe of the fill to protect the wetland/watercourse area behind.
Construction Fence:	No construction fence is required. The silt fence acts as a construction one.
Anti-tracking pad:	No anti-tracking pad, the access will be via the existing driveway.
Other:	I met with the contractor and the owners. We walked the site, and I provided a copy of the approved site plan and the planning plan for their reference.
Notes:	The site is ready for the activities.
Follow-up required:	Yes, after the fill is removed but before the planting activities.

Double line of silt fence with hay bales in between. View from the west of the northern and middle section.

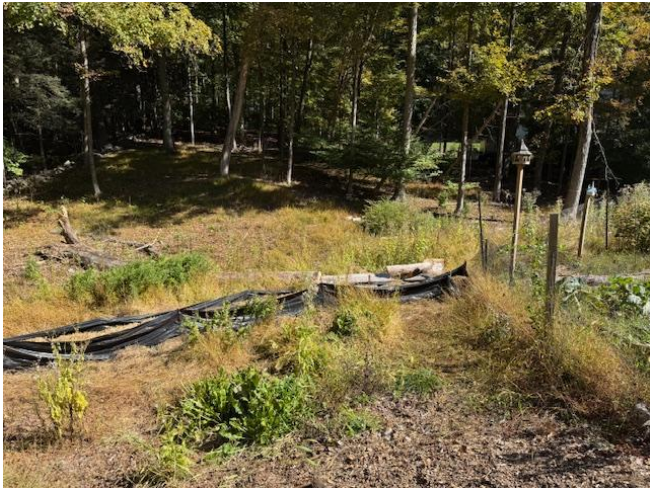
Double line of silt fence with hay bales in between. View from the west of the southern stretch. A. Moch 10/3/2025
